PRESERVATION
ARCHITECTURE

THE PETALUMA SILK MILL

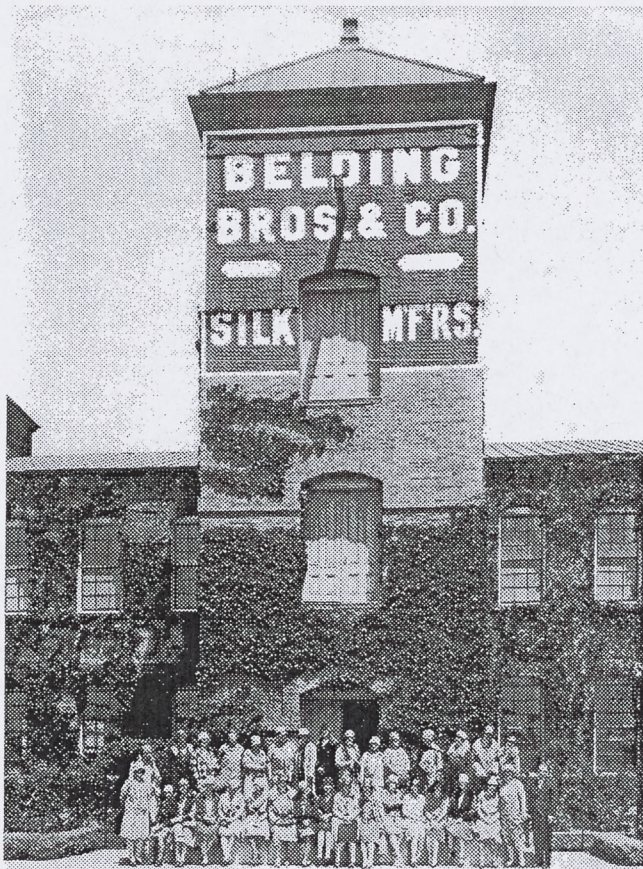
Fig.4: Petaluma Silk Mill c1929
View of North Tower (Courtesy the Petaluma Museum)

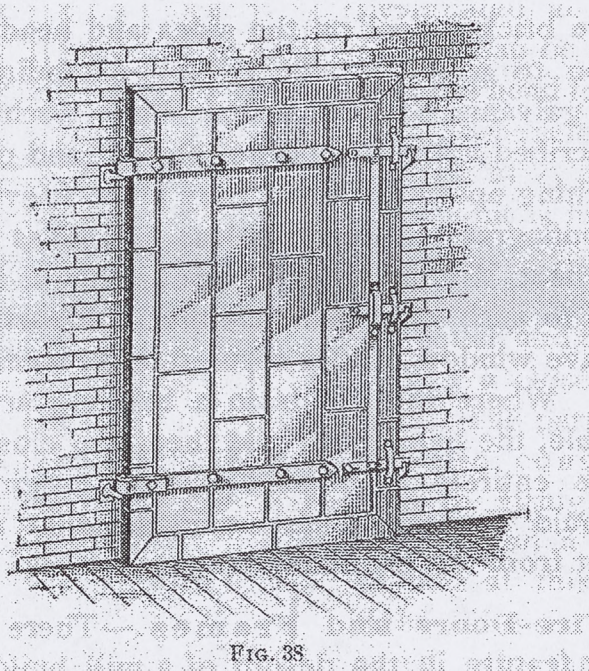
Other standard fire prevention treatments incorporated into the PSM include tin clad and lined fire doors, in particular the rolling door that separates the main

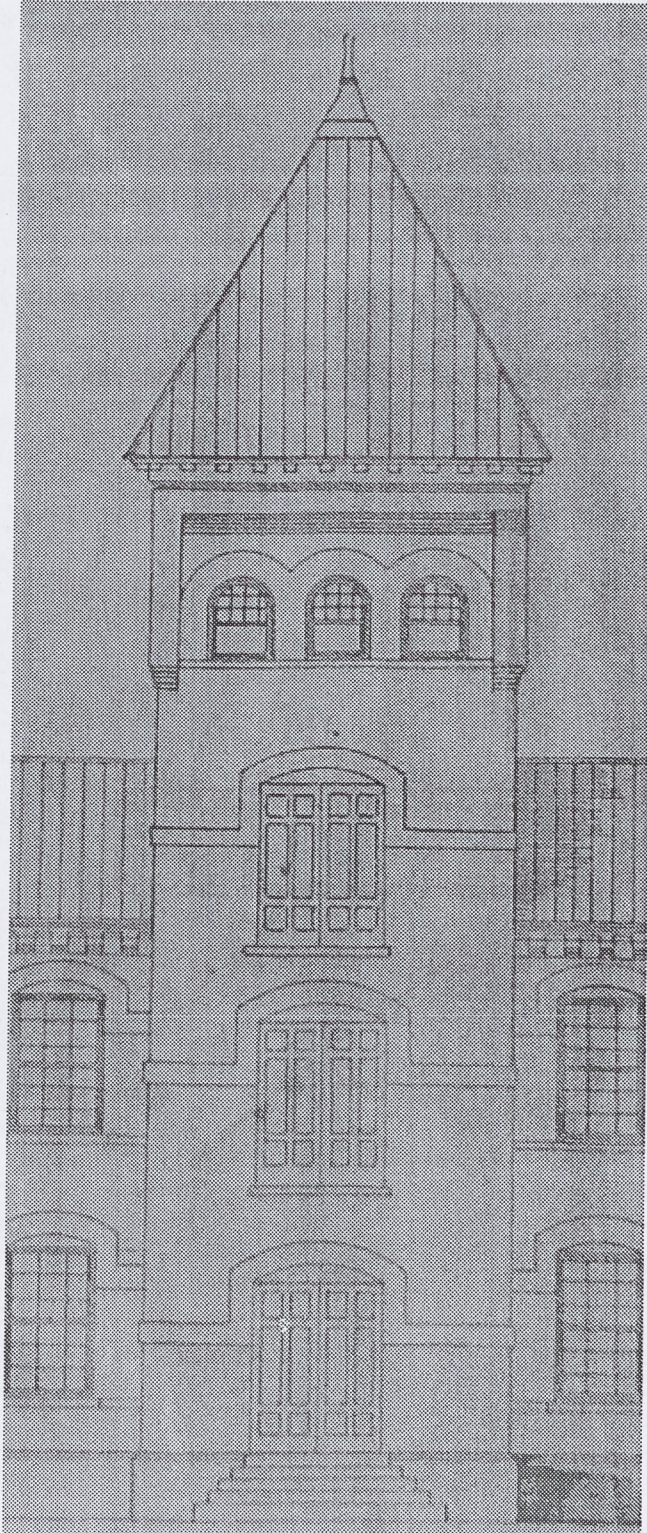
Fig.7: North Tower
Original 1892 design of North Tower (unbuilt)

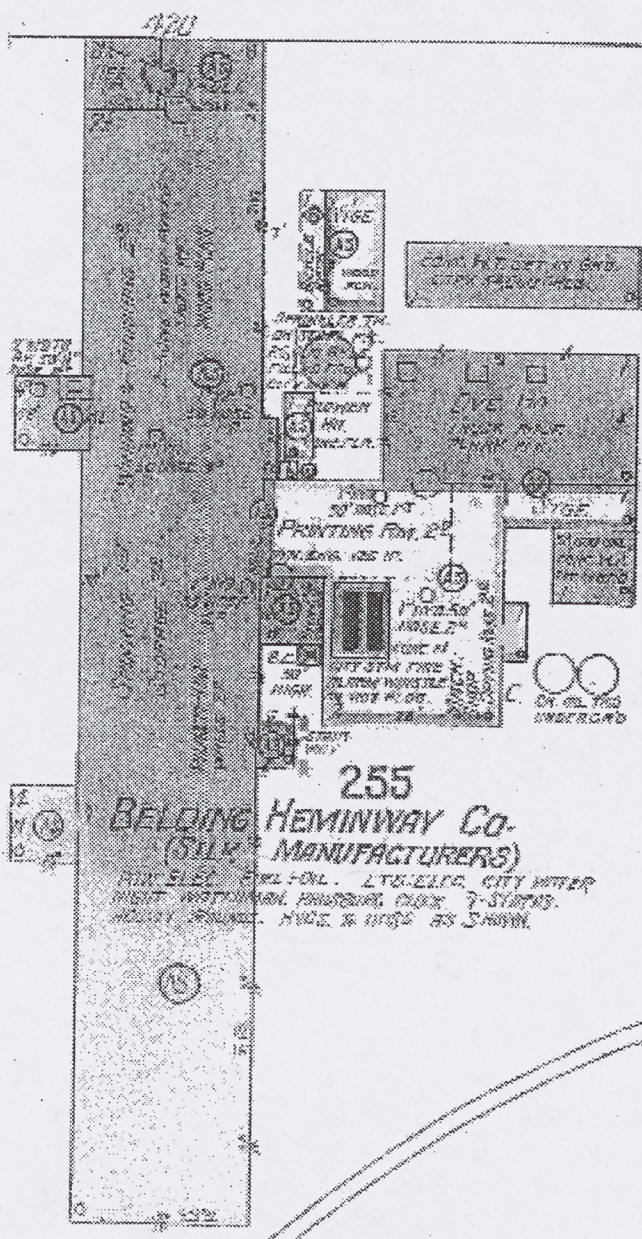
Fig.8: Petaluma Silk Mill
Sanborn Fire Insurance Map, 1926

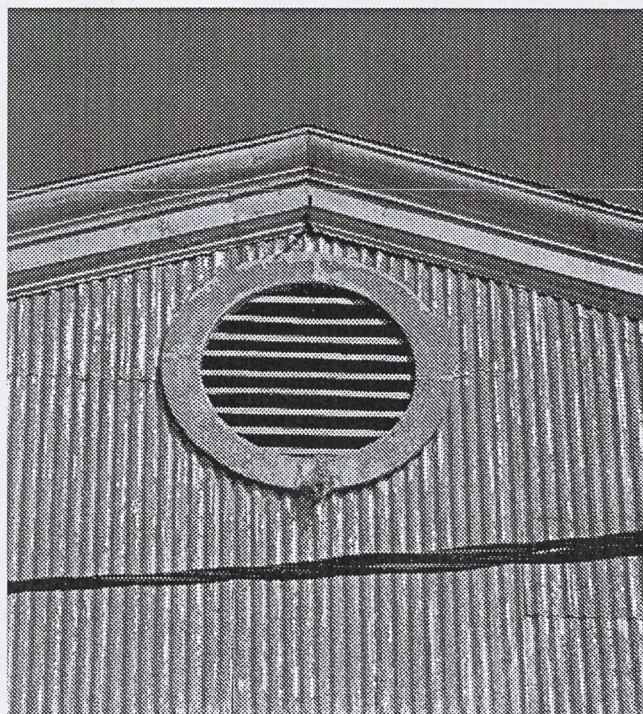
Fig.12: Engine/Machine Room Building
Significant exteriors

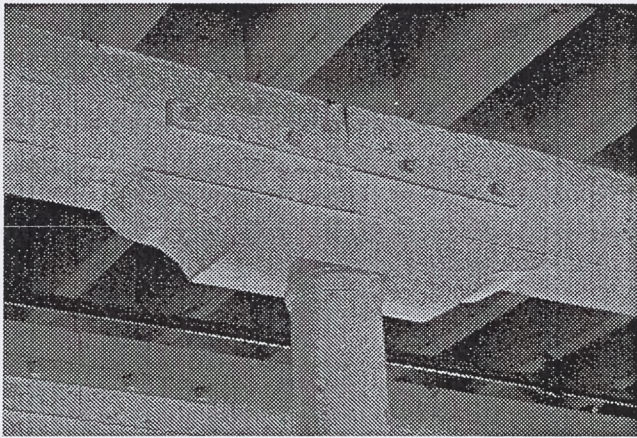
Fig.13: Main Building Interior - Contributing
Contributing interior

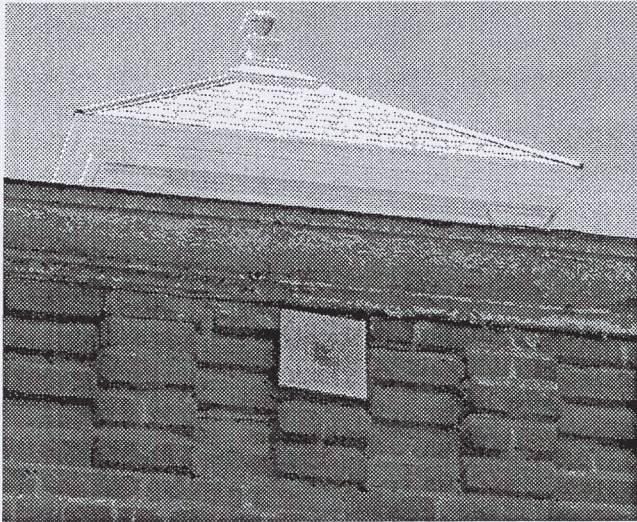
Fig.16: PSM Main Building, West (Front) Elevation

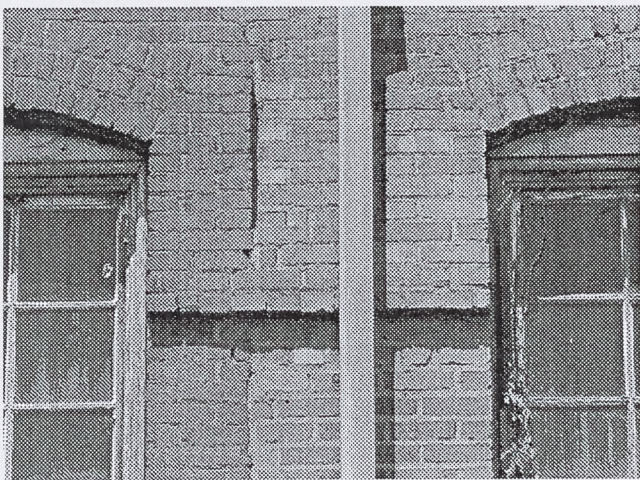
Fig.17: PSM Main Building, West (front) Elevation

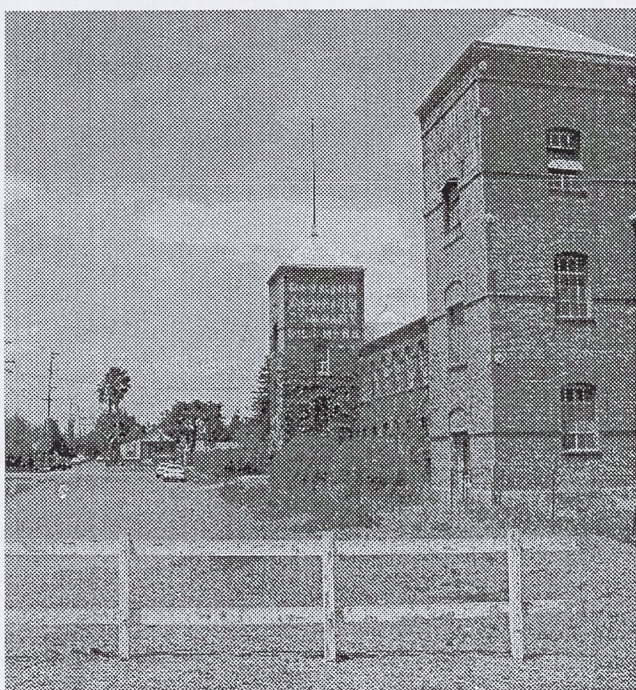
Fig.25: PSM Main Building, Site

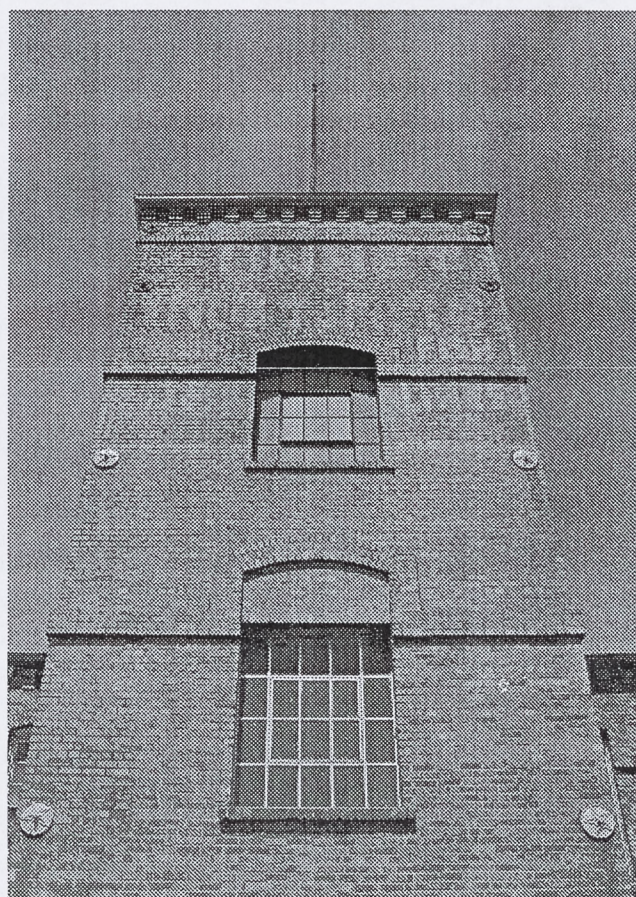
Fig.37: Petaluma Silk Mill
South tower, west elevation

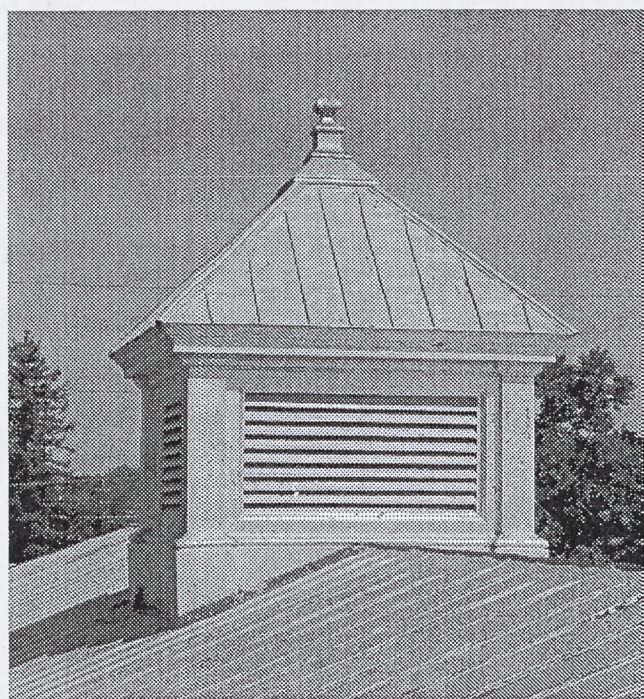
Fig.39: Petaluma Silk Mill
North cupola at main building roof

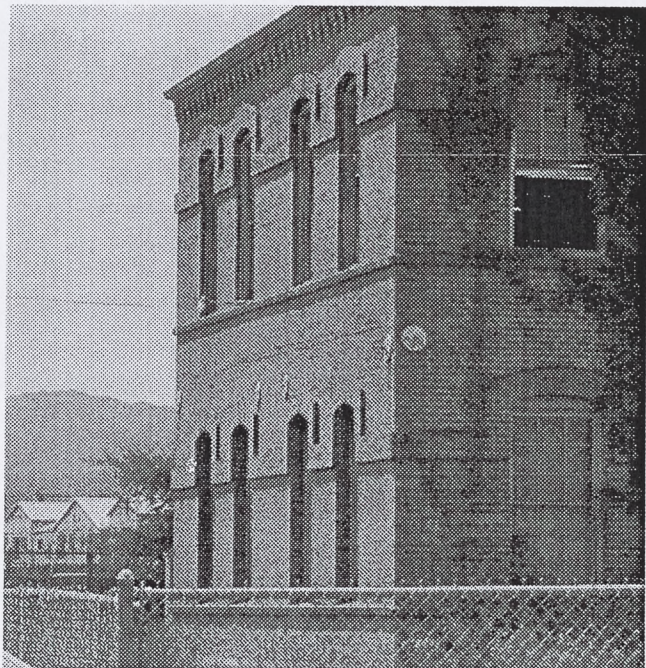
Fig.43: Petaluma Silk Mill – Main Building
South elevation

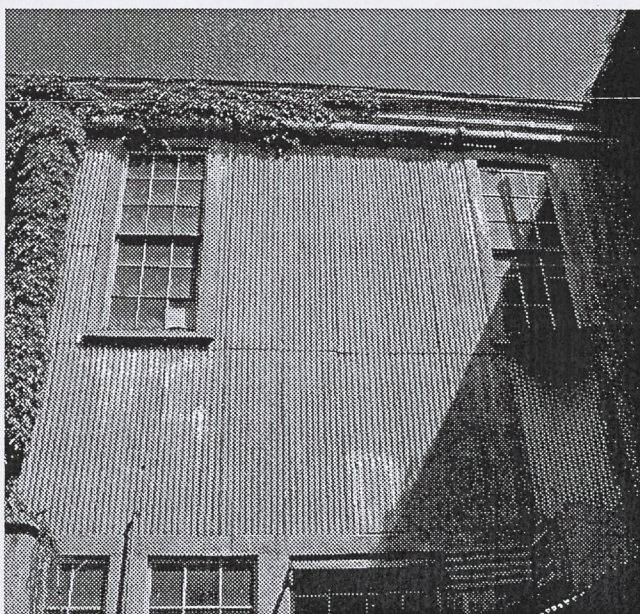
Fig.44: Petaluma Silk Mill – Engine/Machine Room Building
North elevation

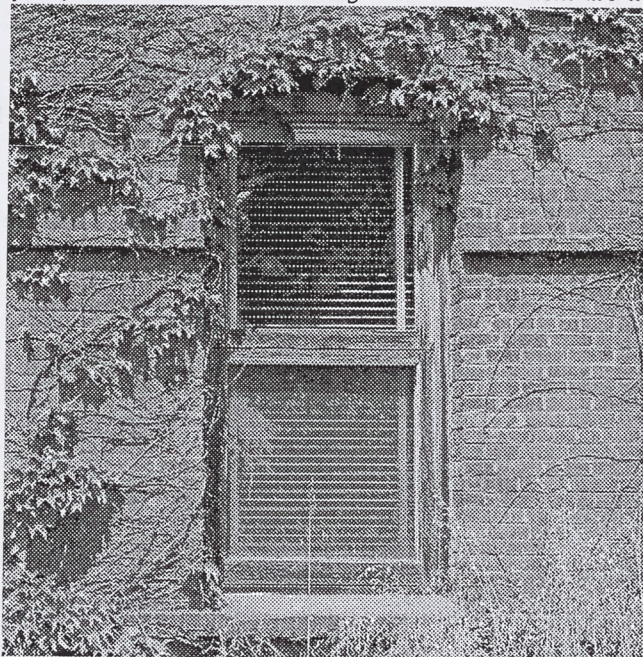
Fig.44: Petaluma Silk Mill – Main Building
Wood window at north end of west elevation

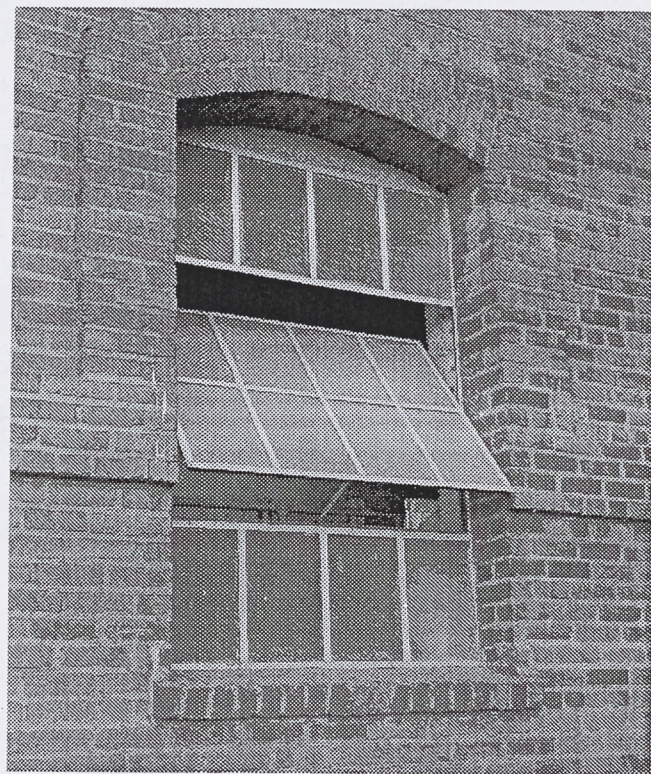
Fig.45: Petaluma Silk Mill – Main Building
Steel window at south elevation, south tower

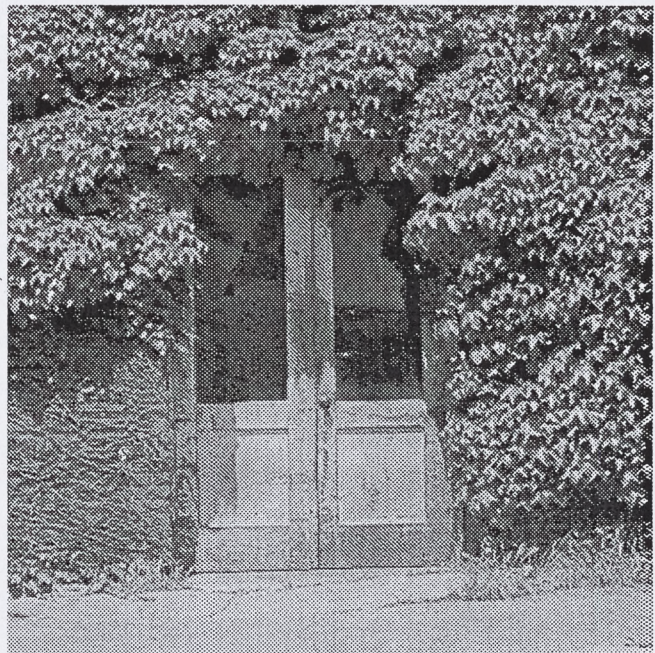
Fig.46: Petaluma Silk Mill – Main Building
Wood entry doors at north tower

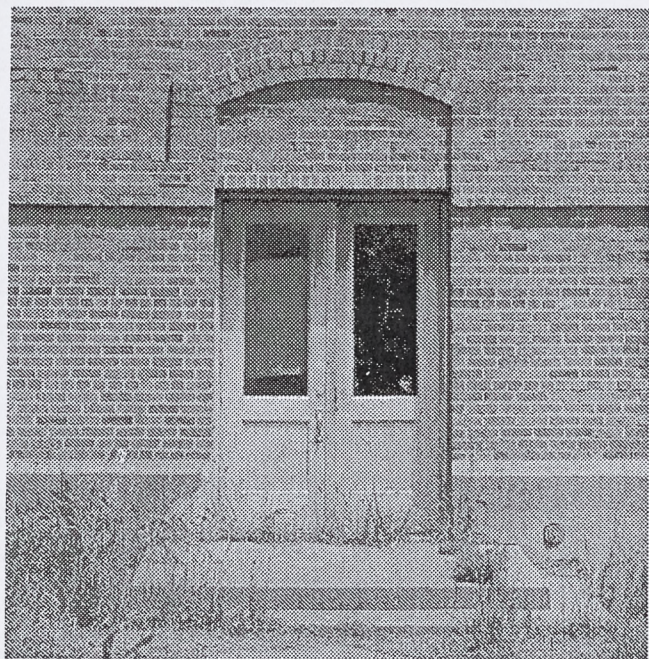
Fig.47: Petaluma Silk Mill – Main Building
Wood entry doors at south tower

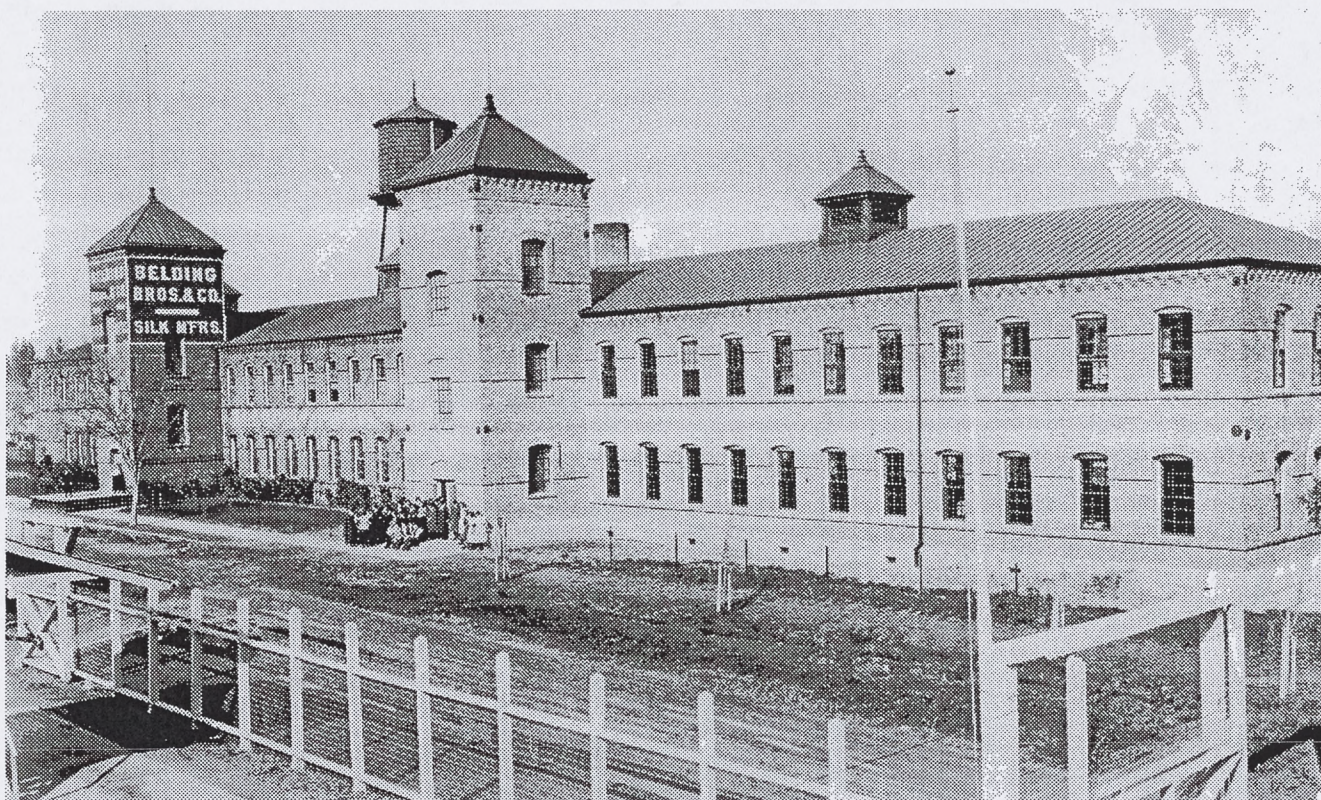
To the extent feasible, these floors should be retained, at least as substrates to new finished flooring.
